River Wall Defences on the Deben – Recent History

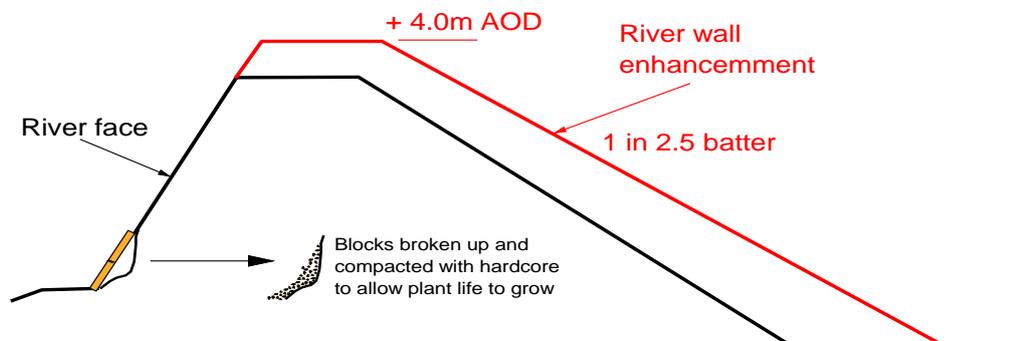
Figure 2: Work on River Wall near Sutton Hoo – 2008

Work on River Wall near Sutton Hoo – 2008 (described in No 49 edition of *The Deben*) The owners of three houses close to the river below Sutton Hoo agreed in the early 2000s that they should repair the river wall protecting their land. In 2008 EA gave limited consent to carry out work on this section of the river wall (see Figure 2). This was carried out to the owners’ specification for a length of wall of about 1Km, following discussions with a number of experts (including Andrew Hawes and people in the Essex Coast Organisation):

- Raise the height, where it was low, to at least the minimum recommended level of 4.0m AOD. This made allowance for 200mm settlement.
- Clay was brought in since the existing soil in the marsh land was not considered acceptable quality.
- A land side batter of 1:2.5 was created.
- The wall was planted with grass. This is intended to ensure that the wall can survive overtopping without breaching.
- At some of the places in the past, owing to lack of saltmarsh, Essex blocks had been placed at the base of the wall on the riverside. Erosion had taken place behind the blocks. In these places the blocks had been broken up and mixed with hardcore to form a wave resistant armour (see Detail to Figure 2). This has allowed spartina grass to grow quickly and create a grass barrier.

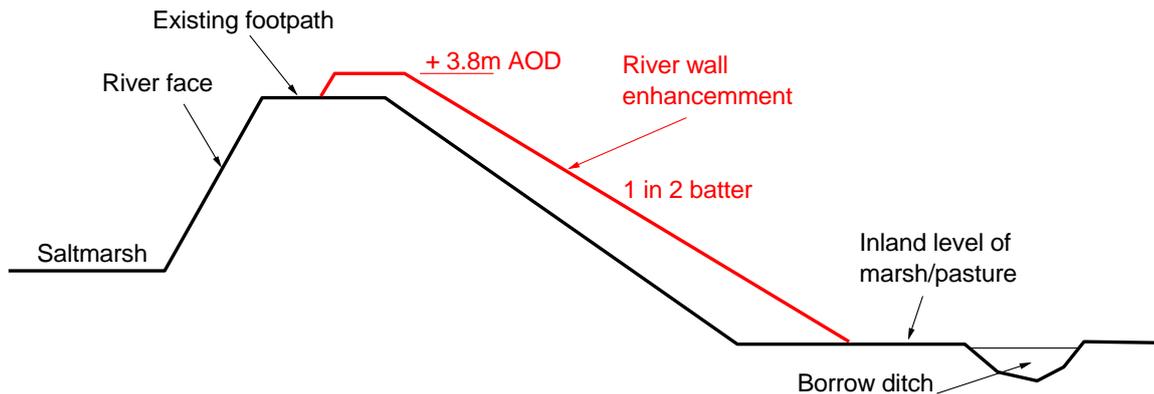
Figure 3: Work on River Wall at Ramsholt – 2014

Work on River Wall at Ramsholt – 2014 (described in No. 51 edition of *The Deben*): The work on the river wall at Ramsholt was carried out to Andrew Hawes' specification:

- The work was for a 400m length of wall.
- The wall back slope was set to a minimum batter of 1:2 (see Figure 3).
- The top of the wall was set at 3.8m AOD with allowance for 100mm settlement. The top of the new wall is set back from the existing wall leaving the footpath on the existing wall open (throughout the remedial work).
- The new material was taken from the existing marsh/field on the land side.
- Seeding with suitable grass (Seacoat) was included in the work (The Environment Agency uses a standard 'bank mix'). Unfortunately this has not been entirely successful and problems similar to, but to a lesser extent exist, that for the wall repairs at Kirton Creek (see below).

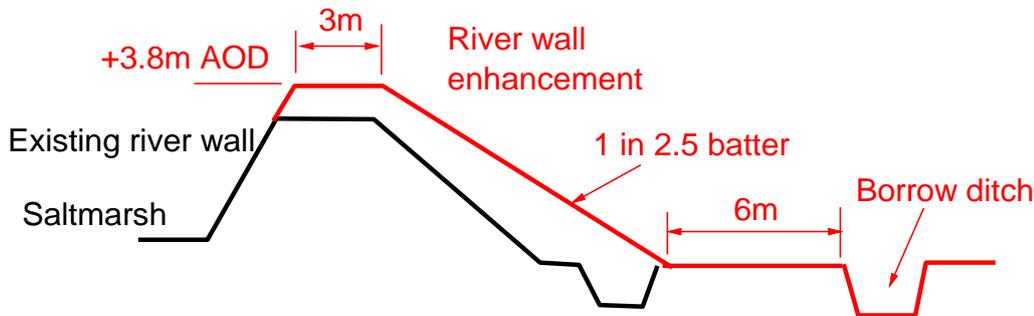
Figure 4: Typical section through new river wall at Waldringfield

Work on River Wall upstream of Waldringfield – 2015 (described in No. 53 edition of *The Deben*): Phase 2 of the Waldringfield Flood Defence Group’s project involved both increasing the height and reducing the gradient of the land side slope of the wall for a length of 750m of river wall. The work included the creation of an inland wild life sanctuary along a 300m length part of the wall. The specified dimensions of the revised wall are shown in Figure 4. The level of the top of the wall has been raised to 3.8m AOD .
