River Deben Association

River Deben Association Saltmarsh Research Group

Saltmarsh Research on the River Deben

Researching the causes of saltmarsh loss

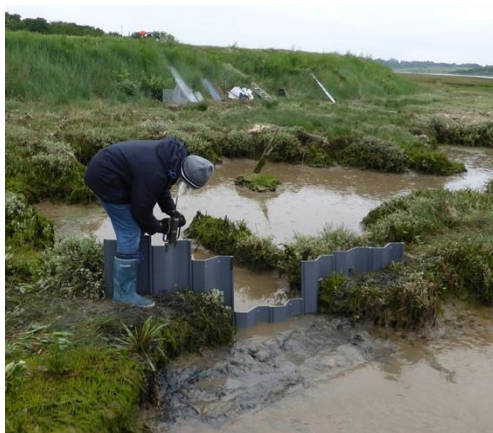
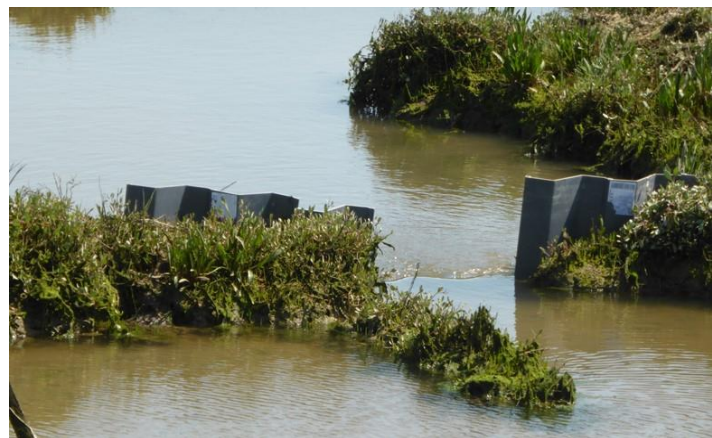
Figure 5: Placing of plastic sheet piling across a drainage channel

The purpose of the pilot study has been to measure changes in saltmarsh level, the erosion at the edges of the saltmarsh and investigate the role that shore crabs and ragworms may have in these changes. Crab exclusion cages and ragworm exclusion plates have been used to assess the effect of crab and ragworm bioturbation on drainage channel sedimentation. In addition, a method of increasing sedimentation in drainage channels using a sill has been investigated. Figure 5 shows the sheet piling (Linlar Std Pile Grey) used to create a sill across a drainage channel. The length of the sheet piles is 1.5m and they have been extended horizontally 0.5m into the saltmarsh to prevent leakage around the ends. The sill is set at 200mm below the level of the saltmarsh.

a) Installing the sheet piling

b) Sill created by sheet piling

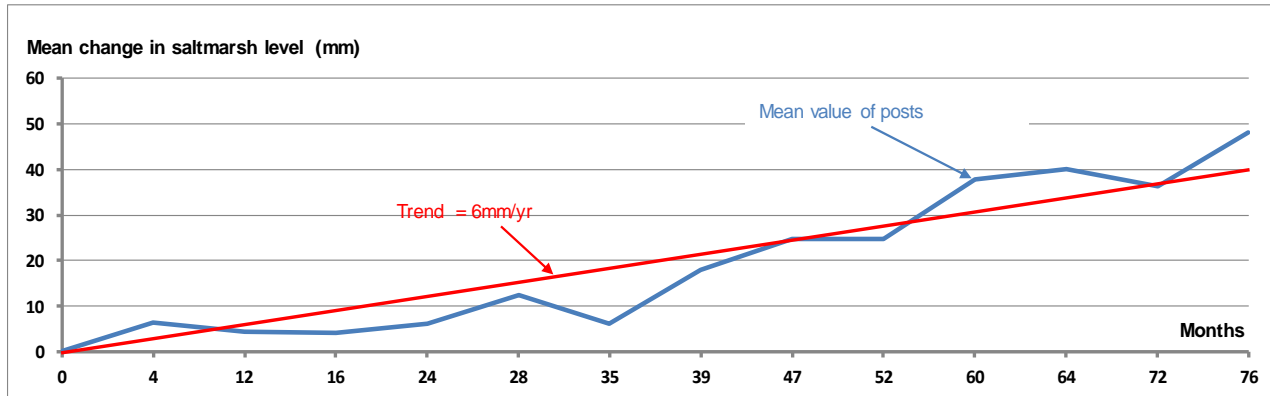
Figure 12: Mean changes of saltmarsh level with time and the trend

6.1.1 Change in level of the saltmarsh: Figure 12 shows the mean of these changes and the trend with time. The trend shows the saltmarsh rising at 6mm/year. This saltmarsh is relatively young (say 150 years old) and its level is low compared with the mature saltmarsh within the estuary, so it should be expected to have a higher rate of increase than sea level rise and the more mature saltmarsh elsewhere in the estuary (about 4mm/year).

The rate of sedimentation is greatest for the least mature saltmarsh at Loder's Cut Island (150 years). The mean rate is 6mm/year over a period of 6½ years, 2½ mm greater than SLR.

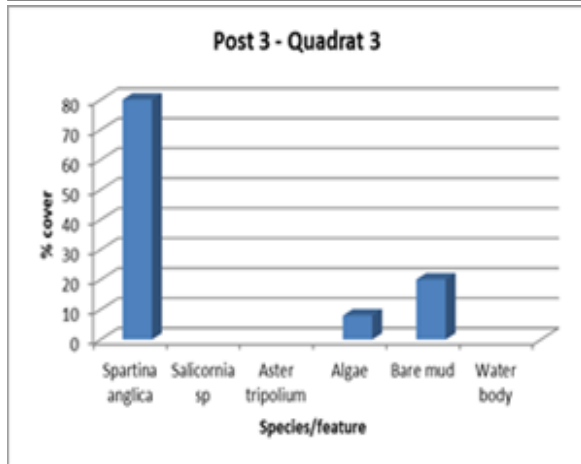
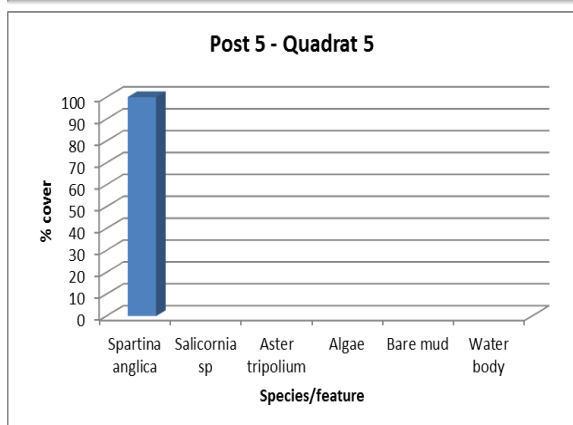
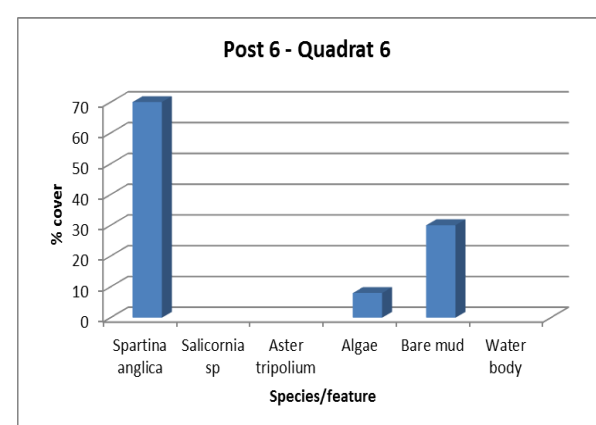
Table A1. Bar charts showing percentage cover of species/features in the quadrats.

Only 4 plant species were found in the quadrats: *Spartina anglica* (common cord-grass), *Salicornia* sp (glasswort or samphire), *Aster tripolium* (sea aster), and algae. With the exception of Quadrat 9, *Spartina anglica* was the dominant species in the quadrats, with cover values ranging from 35 to 100 percent and mostly in excess of 70%. In quadrat 9, *Aster tripolium* was the most widespread species. The vegetation around Post 10 was predominantly *Spartina anglica*. Bare mud averaged 20% over the quadrat area. In several places across the island filamentous algae had spread over eroded bare mud devoid of saltmarsh growth. Most of the island was under water at high tide (Harwich Harbour tide table predicted HW 3.69m). Bar charts showing percentage cover of all the species/features in the quadrats are provided below (Figure 2).

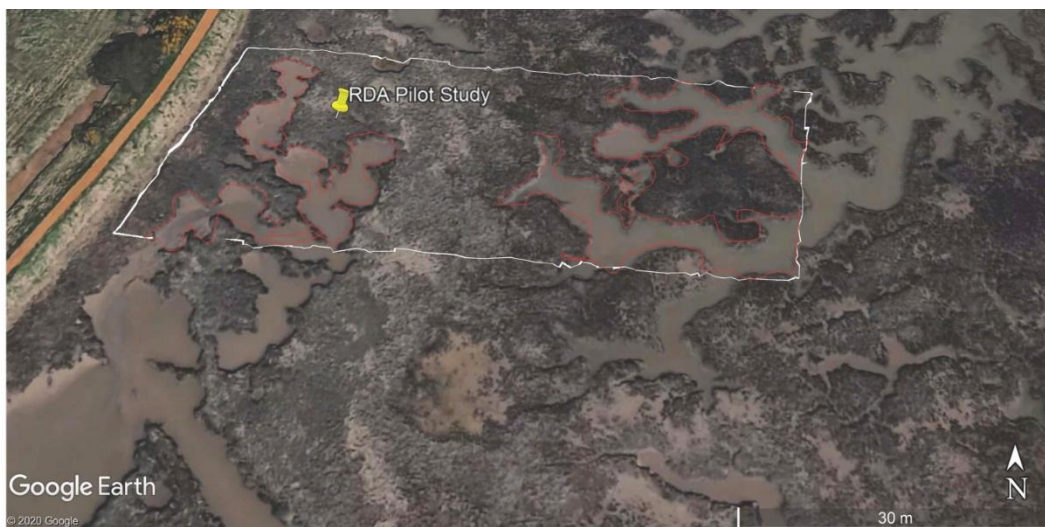
Length of saltmarsh edge = 147 + 123 + 173 = 443m

Hence for 180ha Length is $443 \times 180/0.17 = 469,058\text{m}$

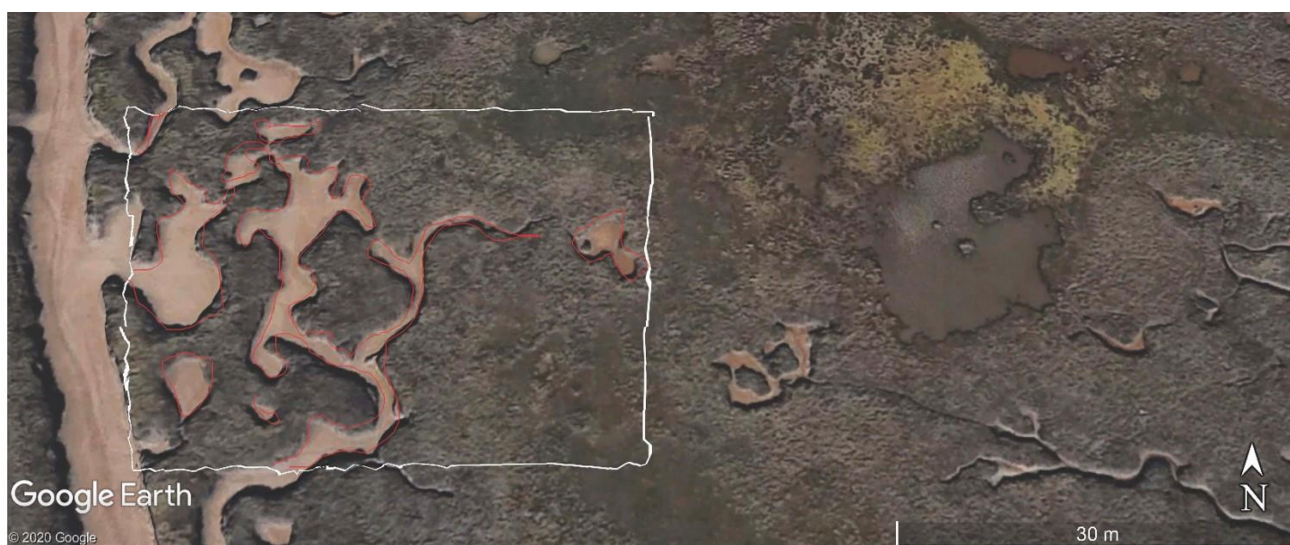
Area 4: Falkenham: Area = 0.13ha

Length of saltmarsh edge = $21 + 186 + 44 + 15 + 6 + 15 + 10 = 297\text{m}$

Hence for 180ha Length is $297 \times 180/0.13 = 411,231\text{m}$
