# When and Why Were Sea Walls Built?

This began as a limited survey of the relationship of clay levels to sea walls, but it developed into a wider investigation of the Deben sea walls.

# Salt Marshes and Sea Walls Briefing

# Dating Sea Walls by Salt Marsh Elevation

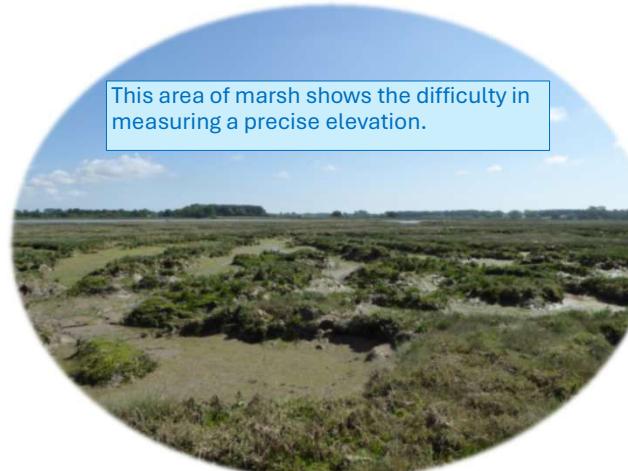
Arnott mentions a method for gauging the approximate build date. A more formal treatment by Richard Steward and Robin Whittle [3] suggested that, to estimate age, the difference between salt marsh elevation and enclosed land elevation is found.

This value is divided by the sum of the annual changes in the land elevation, Mean Sea Level (MSL) and tidal range. This results in a duration and hence a date.

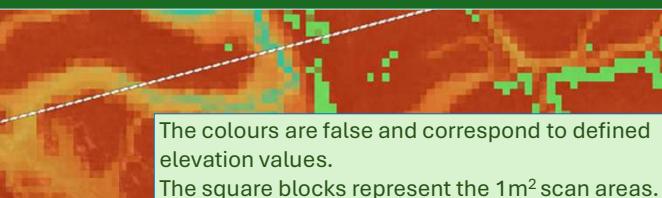
This image shows an example of Hemley Marsh with an estimated elevation of 1.9m. The elevation profile (below) must be interpreted to remove channels.

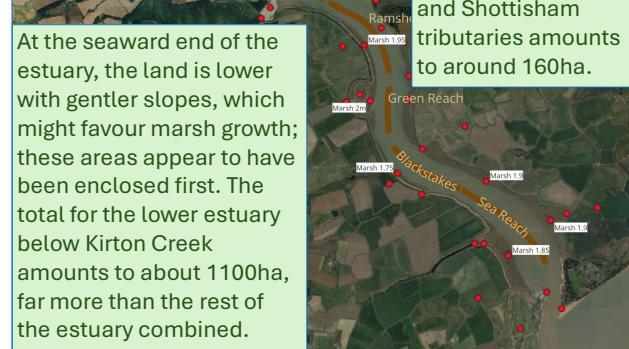
At the seaward end of the estuary, the land is lower with gentler slopes, which might favour marsh growth; these areas appear to have been enclosed first. The total for the lower estuary below Kirton Creek amounts to about 1100ha, far more than the rest of the estuary combined.

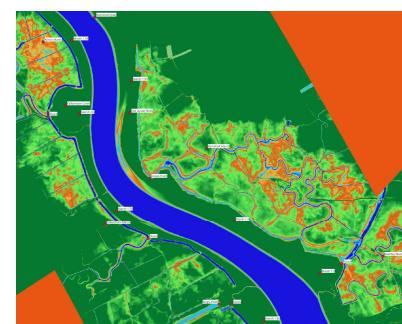
## Detail from LIDAR

False colours in the LIDAR image can be applied to detect small elevation changes. This allows detail to be detected. The image above shows some depressions in the lower estuary, which confound the dating system, unless they are old enclosures.

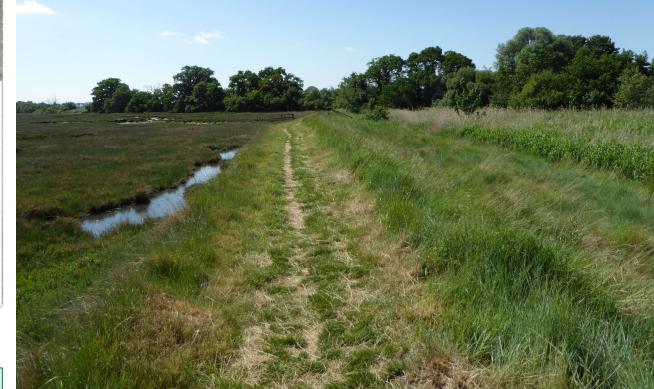
## The Sea Wall by the Reservoir?

The insignificant 150m wall near the reservoir may prove to be the most interesting find of all. However, certain aspects have to be confirmed.

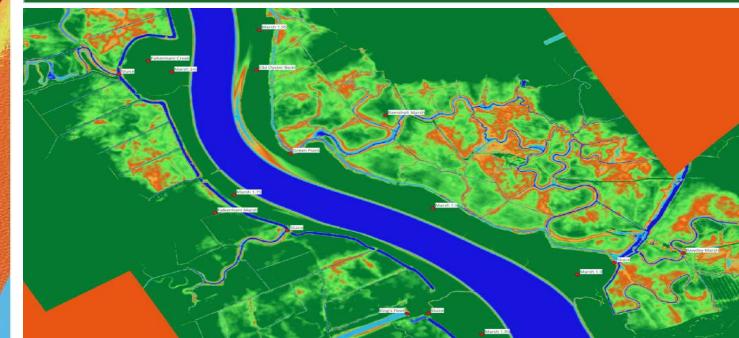
## Depressions confuse Dating by LIDAR

In the lower estuary, there are areas which are up to 0.5m lower than the surrounding enclosure. This will give a date up to 200 years earlier in the worst case (Falkenham). The areas are shown above, with blue being the lowest, through red to green, which is the highest elevation. The range of colours is chosen to enhance detail.

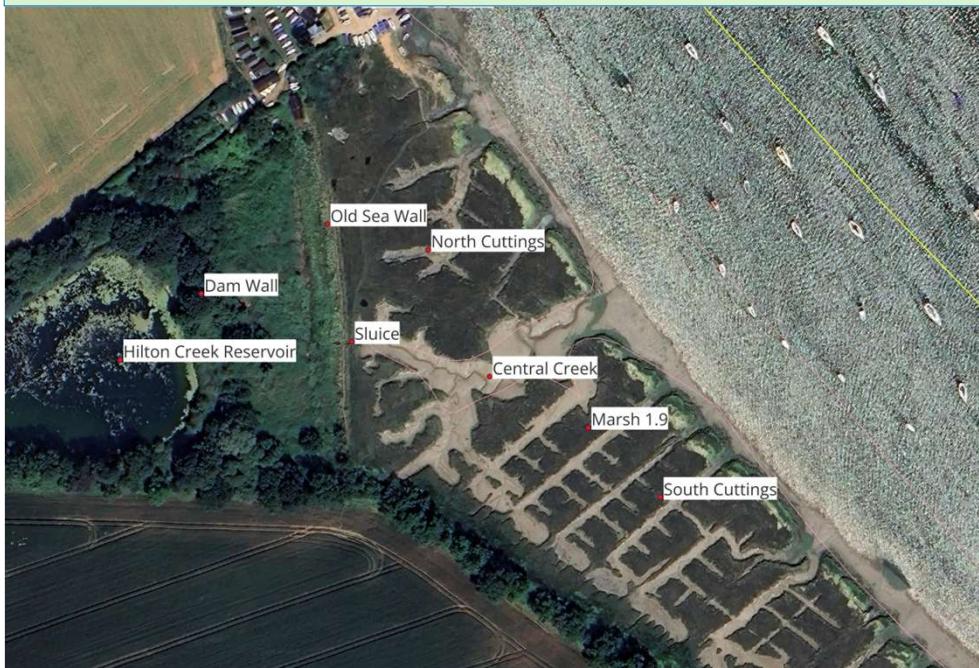
They do not seem interesting until one wonders why there are no similar cuttings on the East Coast and what they were for. The North and South cuttings are different, not made at the same time and divided by the remains of an irregular central creek predating the cuttings. Maps from various dates show their progression.

This area was chosen for investigation of clay levels, discussed elsewhere, for its accessibility. The site has an SSSI sign, although not shown as such on the [Government SSSI map](#).

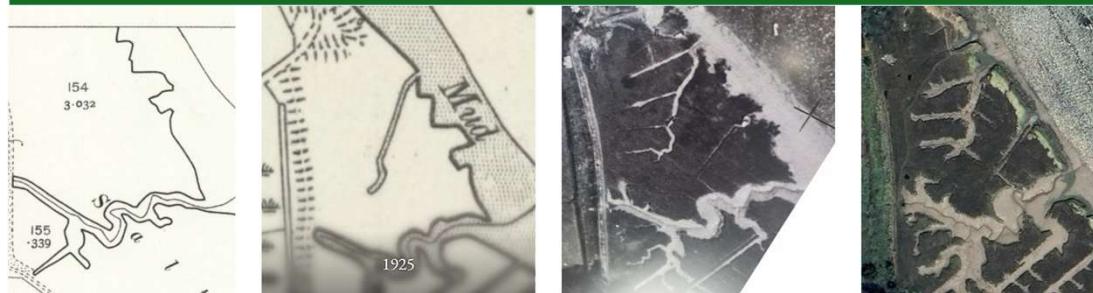
## North Cuttings on Ordnance Survey six-inch from NLS and Google Earth

The more irregular North cuttings are different to the southern ones. The spine channel was cut between 1902 and 1925, with the tributaries between 1925 and 1945. Since 1945, the shape has softened, but no new channels have been dug. The side-by-side view shows the development.

North Cuttings 1902, 1925, 1945, Modern
